**THE AULSON COMPANY, LLC**  
SPECIALTY CONTRACTORS  
**978.688.9100**

## **INDUSTRIAL PAINTING**

### **Lead Paint Abatement and Coatings Application for Steel Preservation and Exterior Renovation, South Helix House in Cutler, ME**

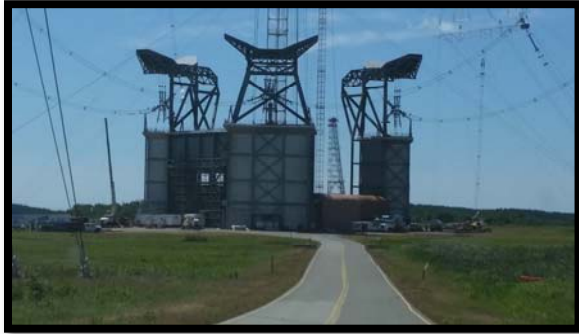
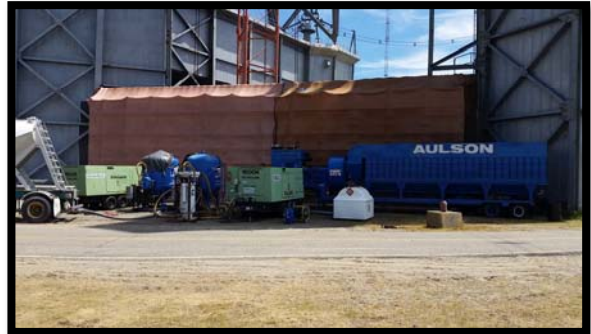
**Description:** Aulson performed lead paint abatement; surface preparation and repair of surface defects; and the installation of a High Performance Coating System at South Helix House. NAVFAC's preservation and restoration of exterior exposed structural steel on the South Helix house at the Naval Computer and Telecommunications Area Master Station, Cutler, ME. The project included scaffolding, containment, surface preparation, high performance coatings, as well as steel repairs and incidental electrical repairs.

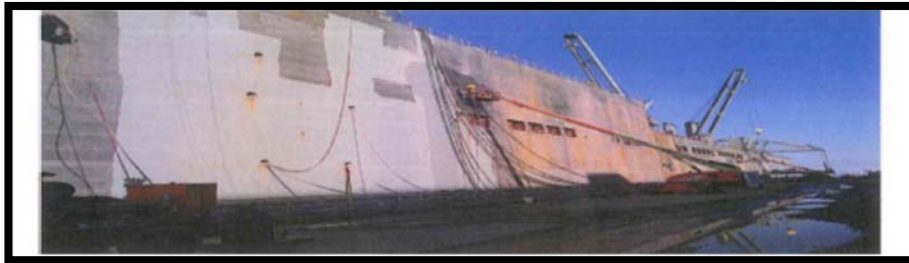
**Marine Coatings Removal, Hull and Structural Painting on USNS Soderman**

**Description:** Aulson performed existing coatings removal on the USNS Soderman described as a Large, Medium Speed, Roll On/Roll Off Ship, which is actively part of the Military's Sealift Command Prepositioning Program. Coatings removal and surface preparation is being performed via UHP Water Jetting. While in drydock the exposed hull is being accessed with various boom lifts and cranes. Following the removal of the existing coatings system, replacement coatings are required to be brush and roller applied to meet current environmental restrictions placed on the shipyard.

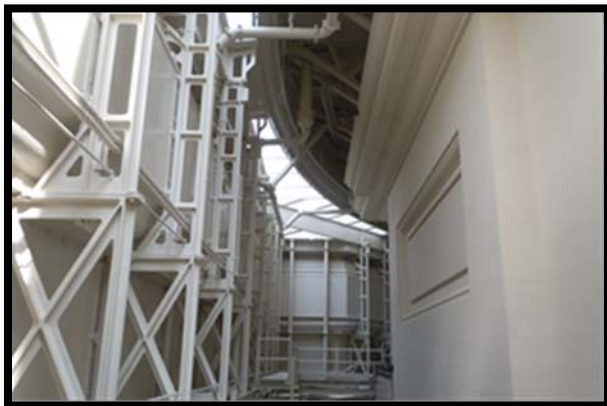
**High Angle Painting – Surface Preparation and Coatings Installation – Including Hazardous Coatings Removal at the United States Capitol Dome in Washington, DC.**

**Description:** All existing hazardous lead-containing paint was removed from the entire Skirt structure including all structural cast iron within the Skirt. This entire project was done under full containment and negative air while Congress was in session. Performed surface preparation via abrasive blasting. After the coating was removed and prior to the installation of a new high performance coating system, the Architect identified and scheduled for repair, the defects, cracks, and joint failures in the Skirt's cast iron plates. All lead paint and hazardous waste materials were disposed of in accordance with all Local, State, and Federal Regulations.

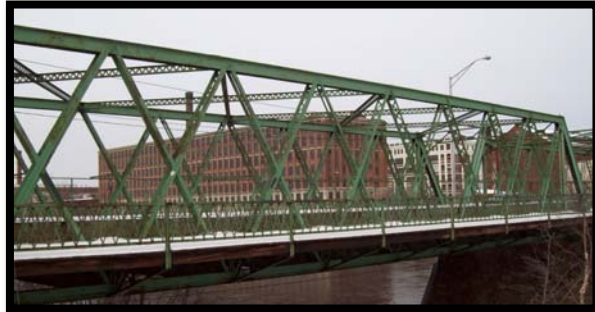
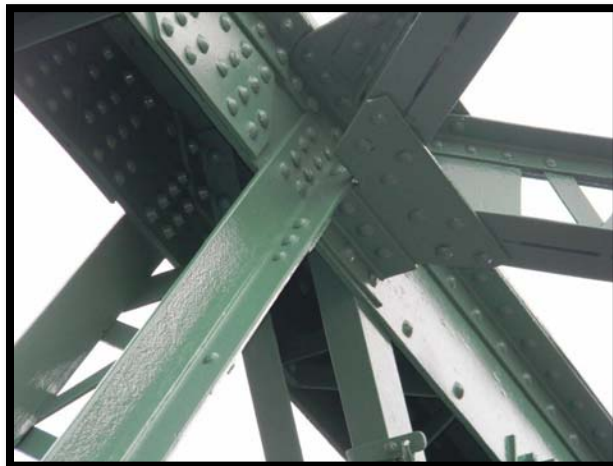
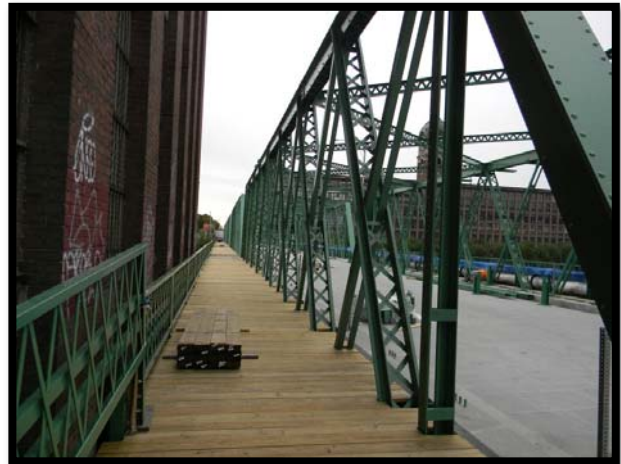
Complex Steel Bridge Structure MassDOT; Union Street (Duck Bridge) Lawrence, MA; Bridge Rehabilitation, including Cleaning (Full Removal) & Painting.

**Description:** The work included the cleaning and painting of all structural steel elements. This surface preparation required full remove in accordance with SSPC SP-10 Near White Metal Standard of cleanliness. The coating system applied was a MassDOT approved NEPCOAT B System by Sherwin-Williams. Duck Bridge is a five-span double-intersection Warren through truss. It is one of the oldest bridges of its kind in Massachusetts.
